**Flood Control Project Maintenance  
Levee Inspections**  
**LMA District Cover Sheet**  
**Spring 2019 Levee Inspection Results**

**Butte County Department of Public Works**

**Spring 2019 Levee Inspection Results**

Waterway			Bank	Unit Miles
Unit No. 01 Mud Creek			Right	6.80
	Spring (March - May)	Summer (June - August)	(September - November) Fall	Winter (December - February)
Unit Maintenance Rating (Fall Only)				
Date of Inspection	4/10/2019 - 4/10/2019			
DWR Inspector	Makar Sokol			
Accompanied By

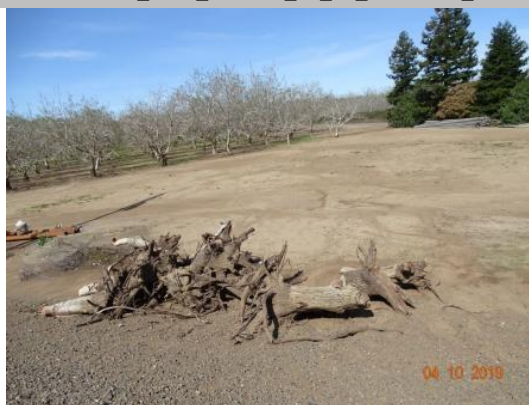
Photo 2 of 2 : SP\_2019\_NA0003\_64\_26\_20190415\_00064.jpg

View of an adjacent pile of tree stumps at the landside toe. Spring 2019.

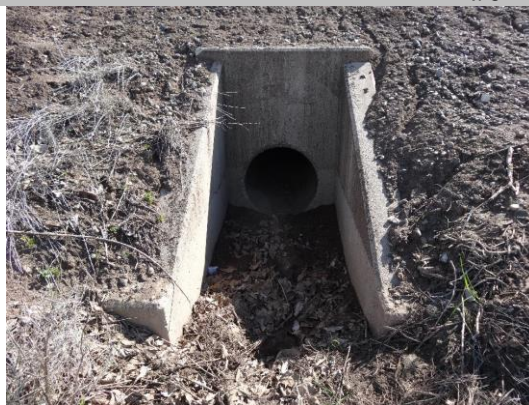
Photo 2 of 3 : UCIP\_SP\_2019\_29705\_54923.jpg

LS view: U typed concrete headwall, CMP on levee slope.

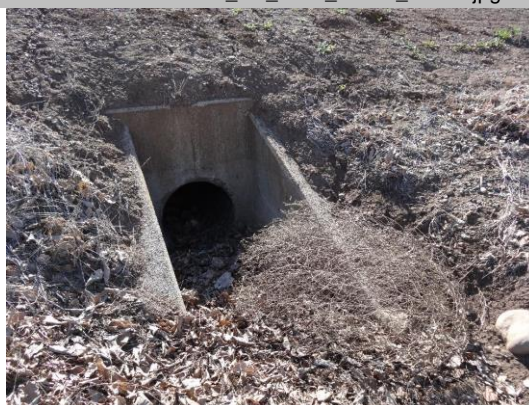
Photo 2 of 3 : UCIP\_SP\_2019\_50142\_55885.jpg

LS view: U type concrete headwall and CMP on levee slope. Vegetation debris blocking inlet.

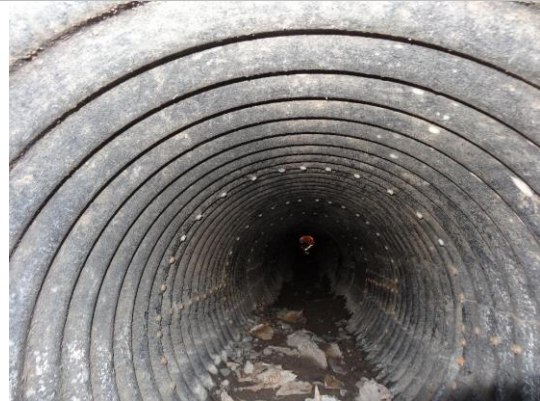
Photo 3 of 3 : UCIP\_SP\_2019\_50142\_55884.jpg

LS view: inside view of CMP on levee slope. Needs cleaning and clearing.

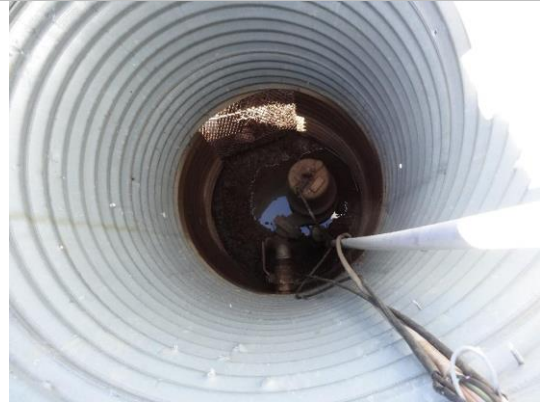
Photo 3 of 3 : UCIP\_SP\_2019\_30291\_55698.jpg

LS view: inside view of CMP riser. Pipe, gate valve, air vent, and submersible pump in the riser.

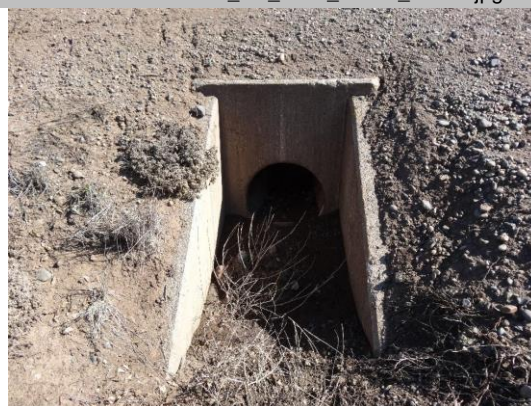
Photo 2 of 2 : UCIP\_SP\_2019\_30294\_55703.jpg

LS view: U type concrete headwall and CMP on levee slope. Debris blocking the inlet pipe.

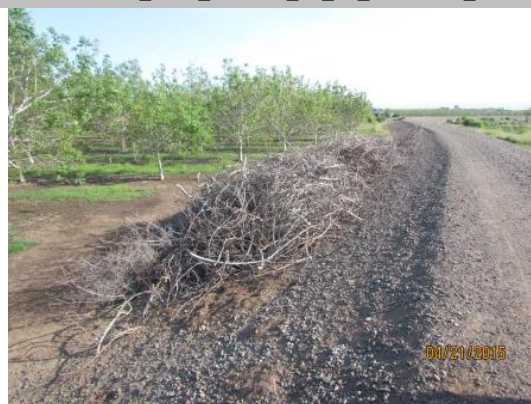
Photo 1 of 2 : SP\_2019\_NA0003\_64\_31\_20190325\_00012.jpg

View of the prunings along the landside slope.

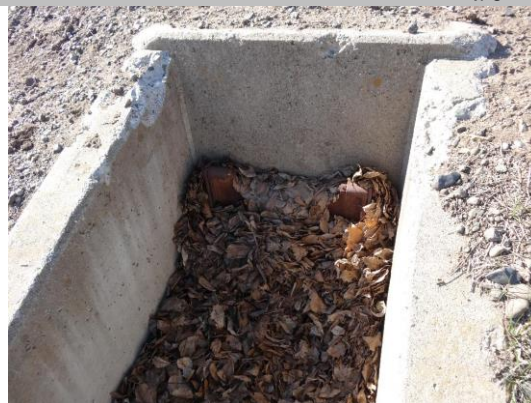
Photo 1 of 2 : UCIP\_SP\_2019\_30295\_55706.jpg

WS view: U type concrete headwall, flapgate on levee slope. Vegetation debris blocking the outlet.

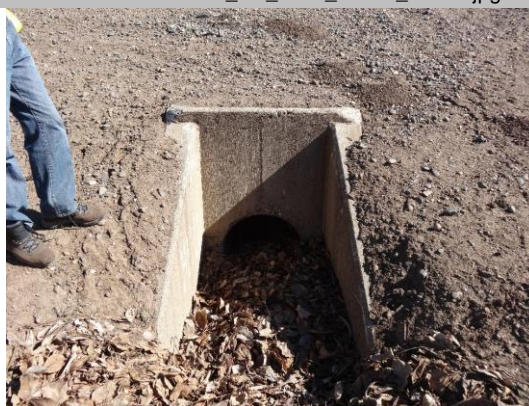
Photo 2 of 2 : UCIP\_SP\_2019\_30295\_55705.jpg

LS view: U type concrete headwall and CMP on levee slope. Vegetation debris blocking the inlet.

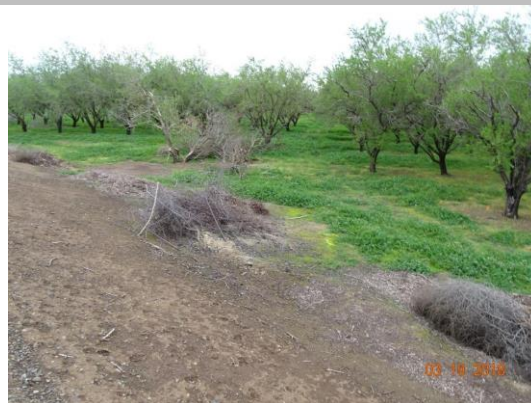
Photo 1 of 1 : SP\_2019\_NA0003\_64\_32\_20190325\_00014.jpg

View of the prunings along the landside toe.

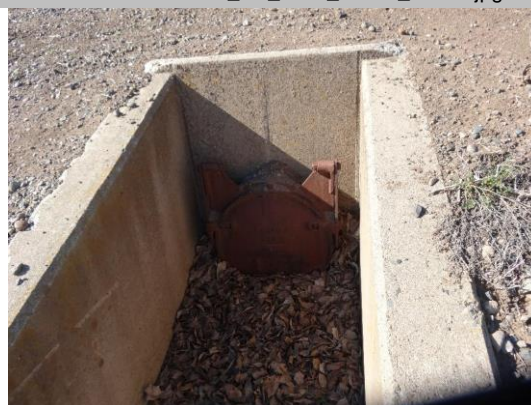
Photo 1 of 2 : UCIP\_SP\_2019\_30311\_55743.jpg

WS view: U type concrete headwall, pipe, and flapgate on levee slope.  
 Vegetation debris blocking outlet.

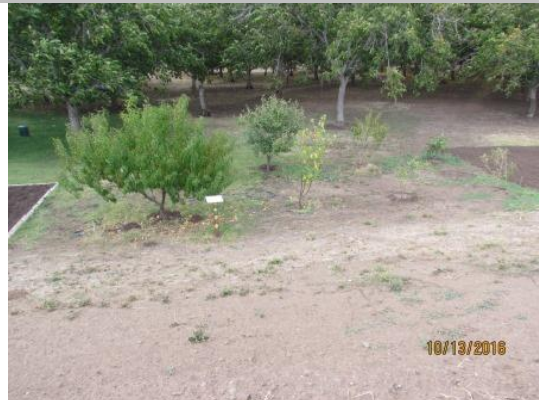
Photo 1 of 1 : SP\_2019\_NA0003\_64\_29\_20190325\_00010.jpg

View of the fruit trees within 10' of landside levee toe.

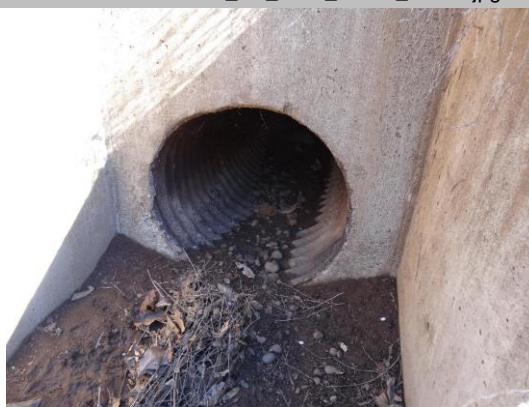
Photo 2 of 2 : UCIP\_SP\_2019\_30312\_55744.jpg

LS view: U type concrete headwall and CMP on levee slope. Needs cleaning and clearing of debris.

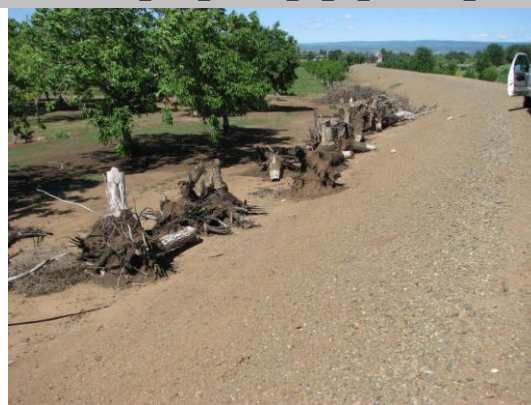
Photo 1 of 1 : SP\_2019\_NA0003\_64\_38\_20190325\_00019.jpg

View of prunings and stumps at the landside toe.

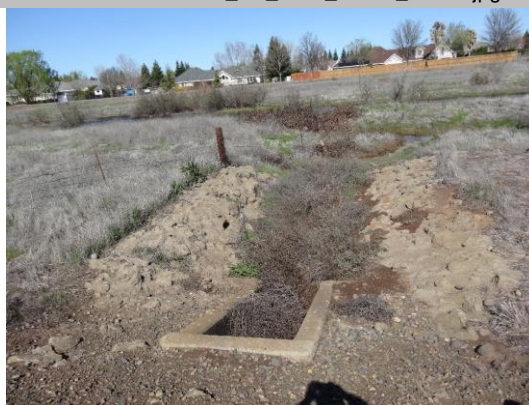
Photo 1 of 3 : UCIP\_SP\_2019\_31667\_57968.jpg

WS view: CMP culvert with U type concrete headwall. Vegetation debris blocking outlet box.

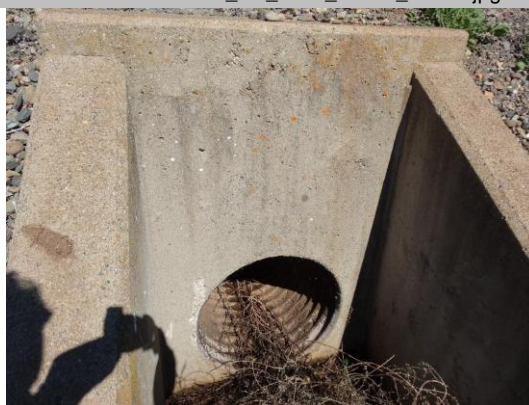
Photo 3 of 3 : UCIP\_SP\_2019\_31667\_57966.jpg

LS view: U type concrete headwall and CMP on levee slope. Vegetation debris on inlet box.

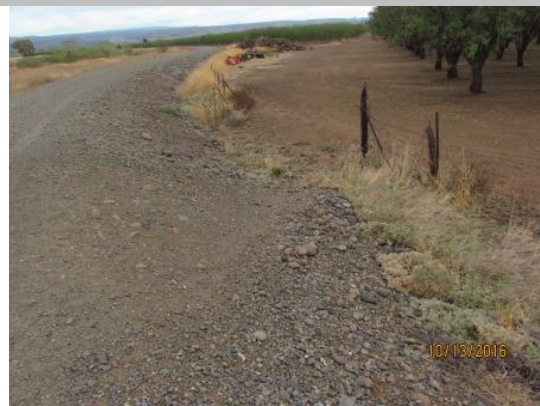
Photo 1 of 1 : SP\_2019\_NA0003\_65\_29\_20190325\_00005.jpg

View of the slope instability caused by vehicles along the landside slope.

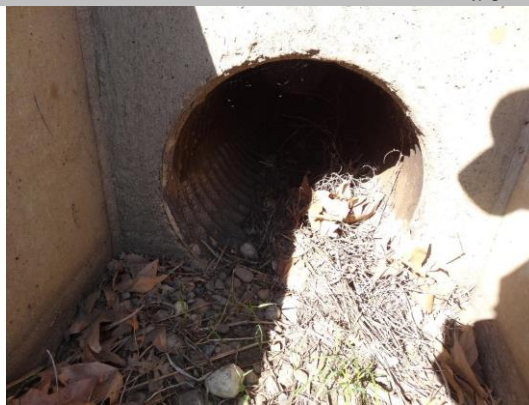
Photo 2 of 3 : UCIP\_SP\_2019\_30403\_55921.jpg

LS view: U type concrete headwall and CMP on levee slope. Vegetation debris in inlet pipe.

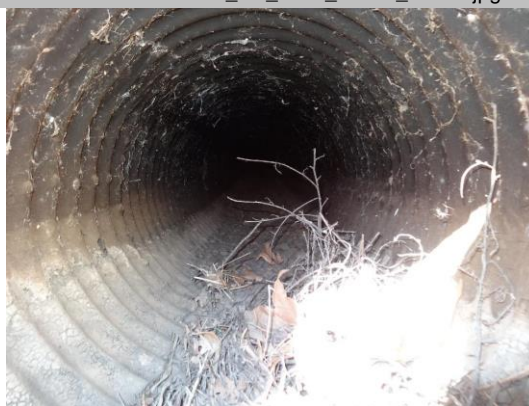
Photo 3 of 3 : UCIP\_SP\_2019\_30403\_55920.jpg

LS view: inside view of CMP on levee slope. Needs cleaning and clearing.

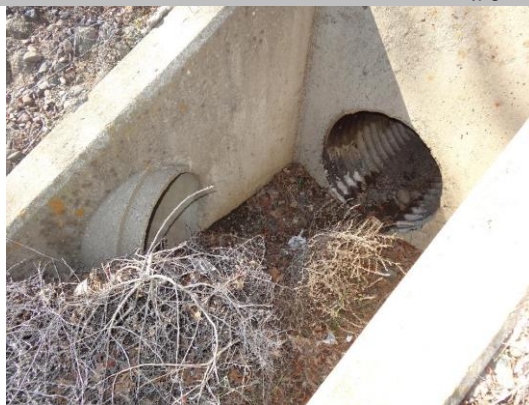
Photo 2 of 2 : UCIP\_SP\_2019\_30743\_56640.jpg

LS view: U type concrete headwall and CMP on levee slope. Vegetation debris and soil in inlet area.

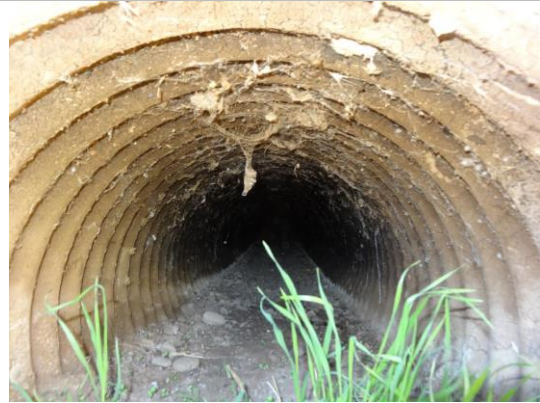
Photo 3 of 3 : UCIP\_SP\_2019\_30763\_56660.jpg

LS view: inside view of CMP on levee slope. Needs cleaning and clearing.

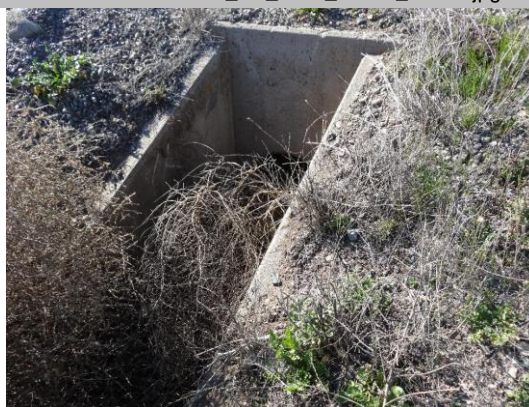
Photo 2 of 3 : UCIP\_SP\_2019\_30803\_56684.jpg

LS view: U type concrete headwall and CMP on levee slope. Vegetation debris and soil blocking inlet.

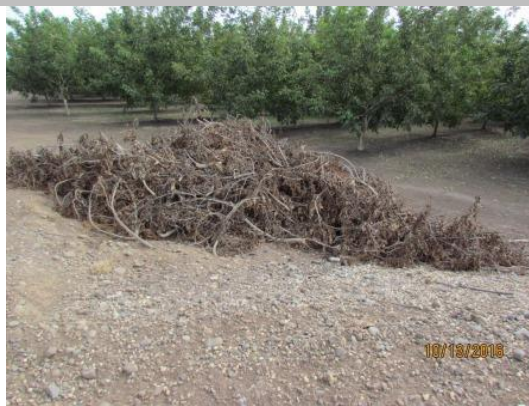
Photo 1 of 1 : SP\_2019\_NA0003\_65\_33\_20190325\_00006.jpg

View of the prunings along the landside toe.

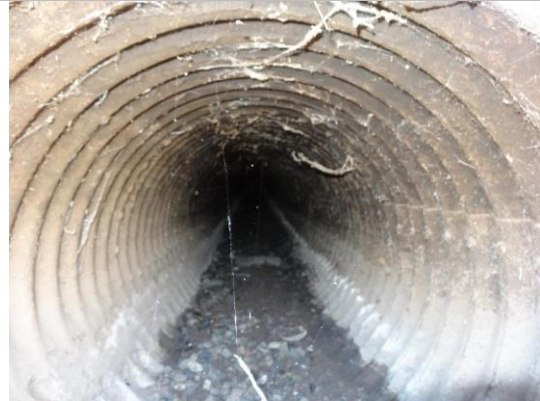
Photo 3 of 3 : UCIP\_SP\_2019\_31028\_56911.jpg

LS view: inside view of CMP on levee slope. Needs cleaning and clearing.

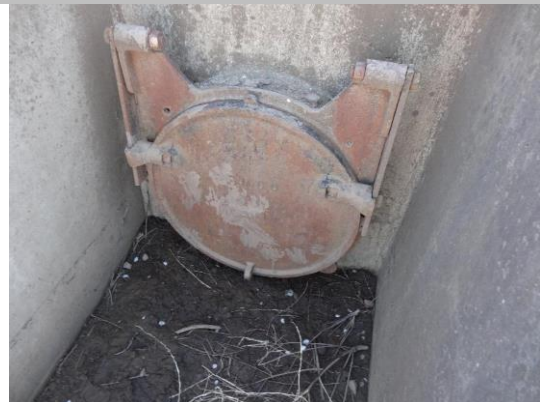
Photo 1 of 3 : UCIP\_SP\_2019\_31031\_56917.jpg

WS view: U type concrete headwall, pipe, and flapgate on levee slope. Soil/mud on outlet box.

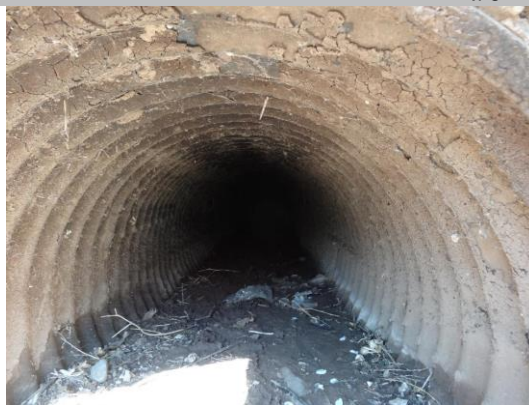
Photo 3 of 3 : UCIP\_SP\_2019\_31031\_56915.jpg

LS view: inside view of CMP on levee slope. Needs cleaning and clearing.

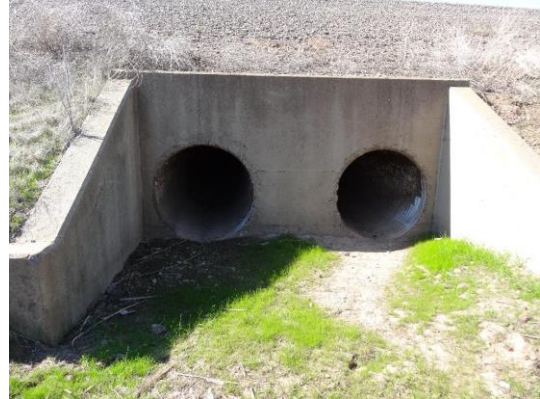
Photo 3 of 3 : UCIP\_SP\_2019\_41377\_56921.jpg

LS view: U type concrete headwall and CMPs on levee slope. Soil/mud on inlet box.

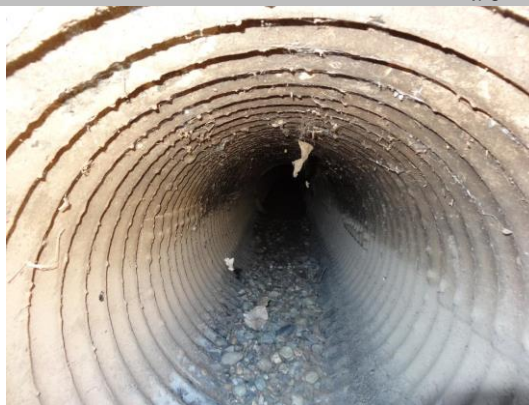
Photo 3 of 3 : UCIP\_SP\_2019\_31034\_56924.jpg

LS view: inside view of CMP on levee slope. Needs cleaning and clearing.

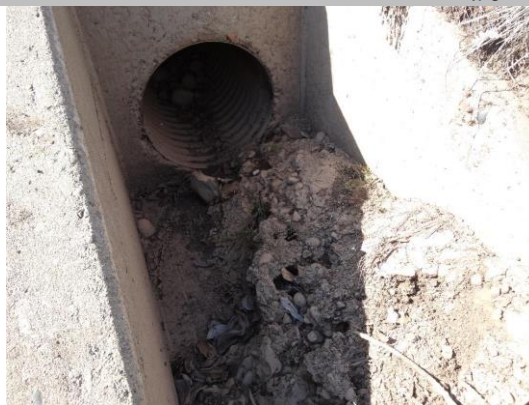
Photo 2 of 3 : UCIP\_SP\_2019\_31085\_56987.jpg

LS view: U type concrete headwall and CMP on levee slope. Soil/mud on inlet box.

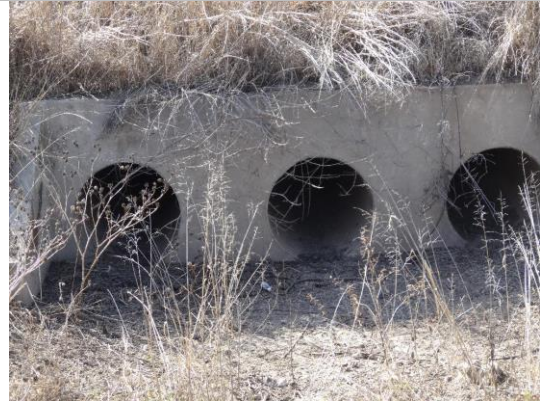
Photo 3 of 3 : UCIP\_SP\_2019\_32085\_58586.jpg

LS view: U type concrete headwall and CMPs on levee slope. Soil/mud on inlet box.

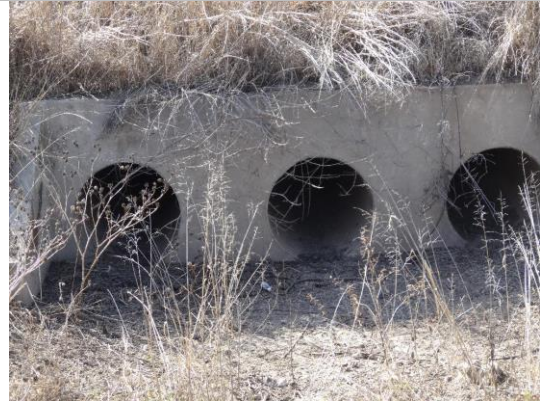
Photo 3 of 3 : UCIP\_SP\_2019\_32086\_58587.jpg

LS view: U type concrete headwall and CMPs on levee slope. Soil/mud on inlet box.

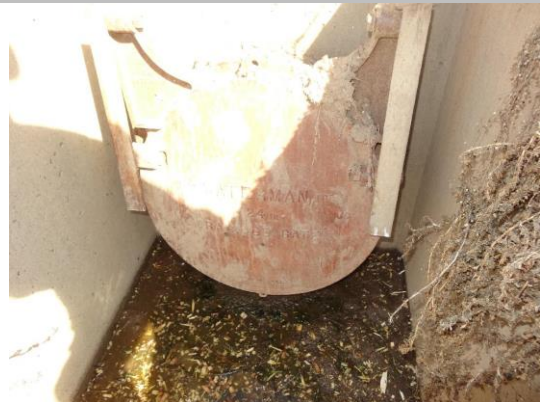
Photo 1 of 2 : UCIP\_SP\_2019\_31129\_57036.jpg

WS view: U type concrete headwall, pipe, and flapgate on levee slope. Soil/mud on outlet box.

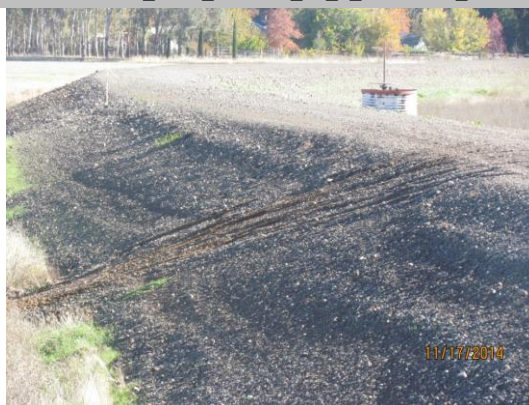
Photo 1 of 1 : SP\_2019\_NA0003\_67\_3\_20190325\_00001.jpg

View of the erosion caused by motorcycles on the landside slope.

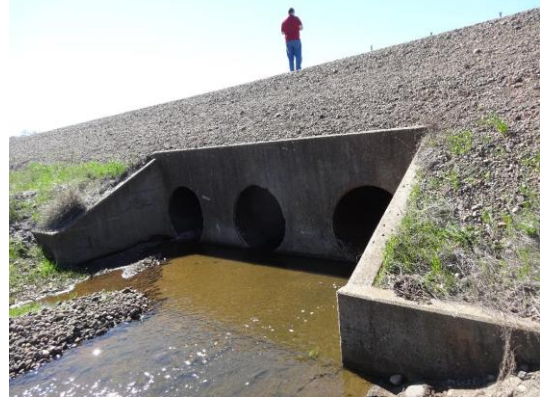
Photo 2 of 2 : UCIP\_SP\_2019\_32104\_58605.jpg

LS view: U type concrete headwall and three CMPs on levee slope. Soil/mud on inlet box.

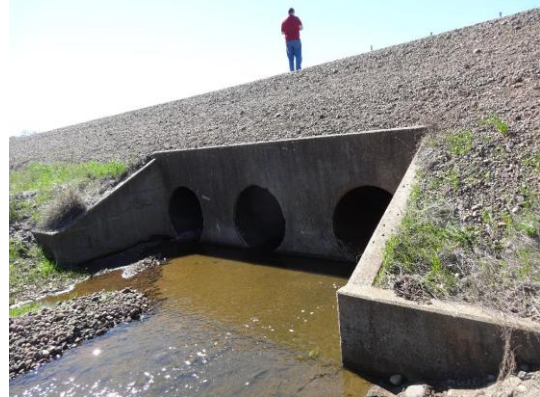
Photo 2 of 2 : UCIP\_SP\_2019\_32105\_58607.jpg

LS view: U type concrete headwall and three CMPs on levee slope. Soil/mud on inlet box.

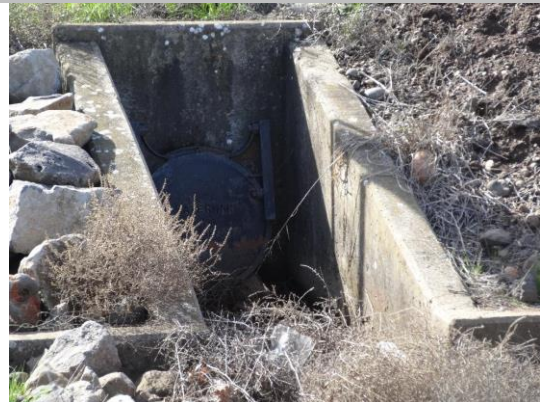
Photo 1 of 3 : UCIP\_SP\_2019\_32124\_58625.jpg

WS view: concrete headwall, pipe, and flapgate on levee slope. Vegetation and mud on outlet box.

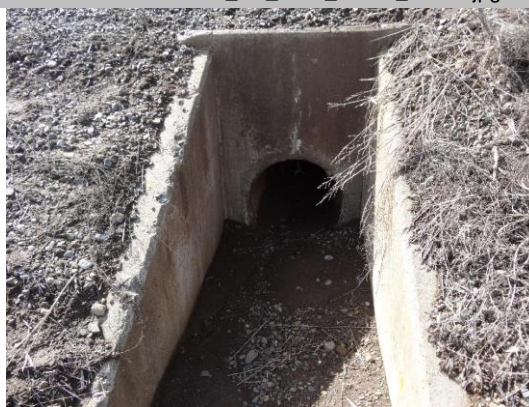
Photo 2 of 3 : UCIP\_SP\_2019\_31901\_58193.jpg

LS view: U type concrete headwall and CMP on levee slope. Soil/mud on inlet box.

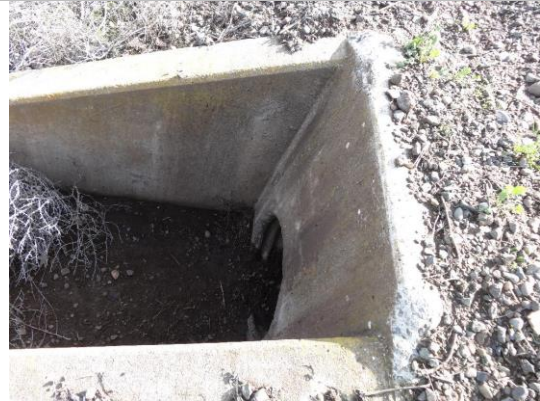
Photo 3 of 3 : UCIP\_SP\_2019\_31902\_58199.jpg

LS view: U type concrete headwall and CMP on levee slope. Soil/mud on inlet box.

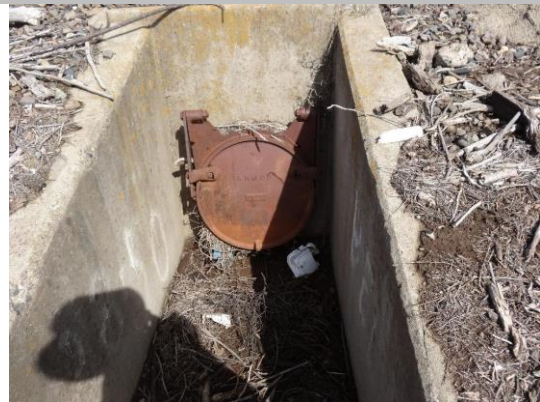
Photo 1 of 3 : UCIP\_SP\_2019\_31864\_58069.jpg

WS view: U type concrete headwall, pipe, and flapgate on levee slope. Soil/mud on outlet box. Vegetation debris blocking outlet box.

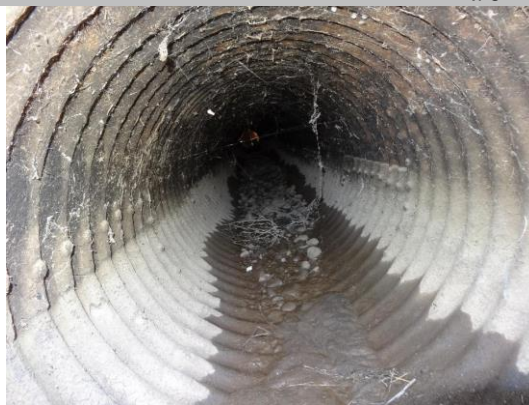
Photo 3 of 3 : UCIP\_SP\_2019\_31864\_58067.jpg

LS view: inside view of CMP on levee slope. Needs cleaning and clearing.

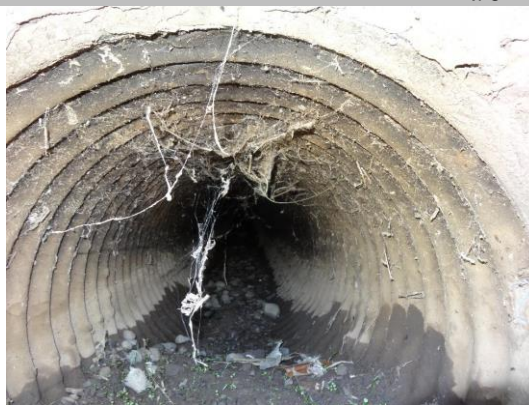
Photo 3 of 3 : UCIP\_SP\_2019\_31856\_58051.jpg

LS view: inside view of CMP on levee slope. Needs cleaning and clearing.

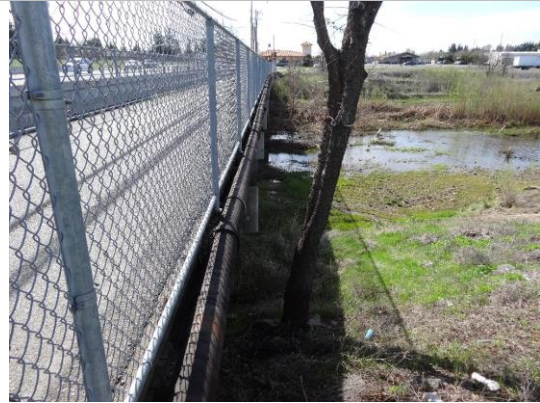
Photo 1 of 1 : UCIP\_SP\_2019\_31851\_58041.jpg

WS view: 6-inch steel pipe attached to Cohasset Road Bridge. Needs confirmation from LMA whether this is a gasoline.

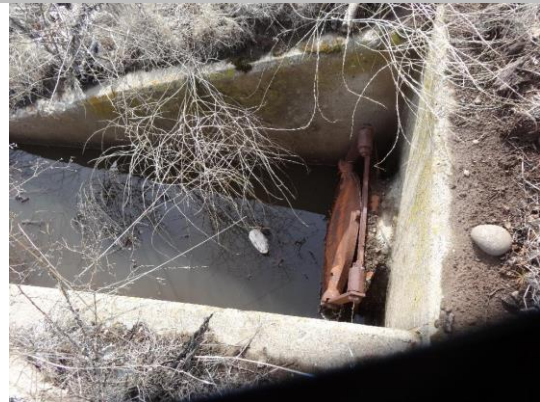
Photo 1 of 2 : UCIP\_SP\_2019\_32125\_58629.jpg

WS view: U type concrete headwall, pipe, and flapgate on levee slope. Soil/mud on outlet box. Vegetation debris blocking outlet box.

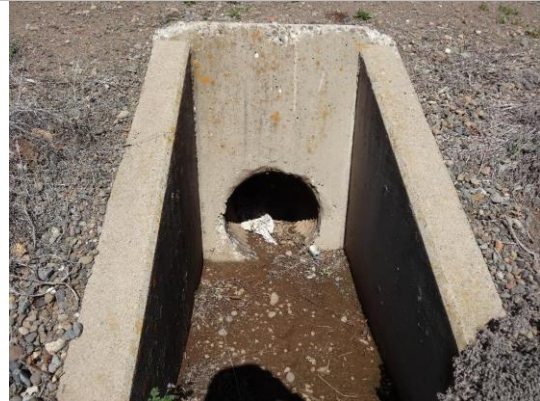
Photo 3 of 3 : UCIP\_SP\_2019\_32026\_58518.jpg

LS view: U type concrete headwall and CMP on levee slope. Mud and pebbles on inlet box.

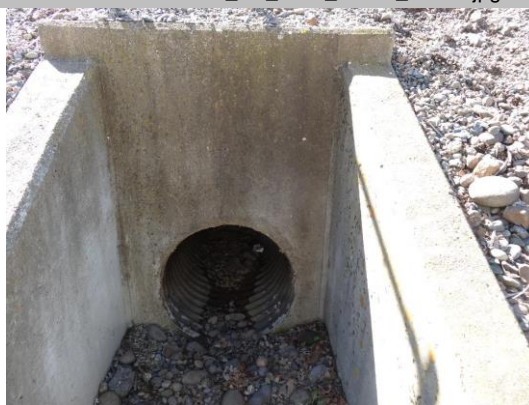
Photo 2 of 3 : UCIP\_SP\_2019\_32023\_58504.jpg

LS view: U type concrete headwall and CMP on levee slope. Pebbles and mud on inlet box.

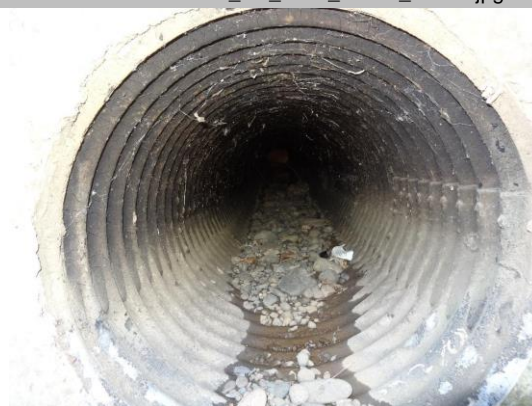
Photo 3 of 3 : UCIP\_SP\_2019\_32023\_58503.jpg

LS view: inside view of the CM pipe. Needs cleaning and clearing the pipe.

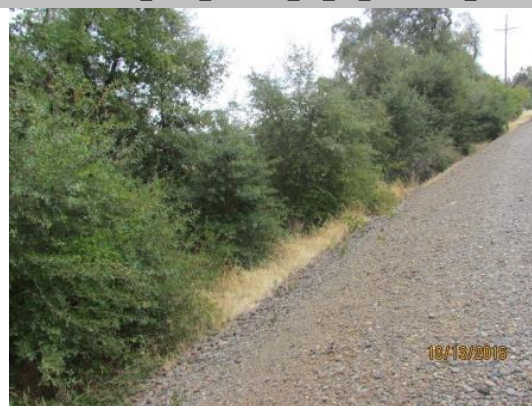
Photo 1 of 1 : SP\_2019\_NA0003\_68\_21\_20190325\_00006.jpg

View of the overgrown trees along the landside toe.

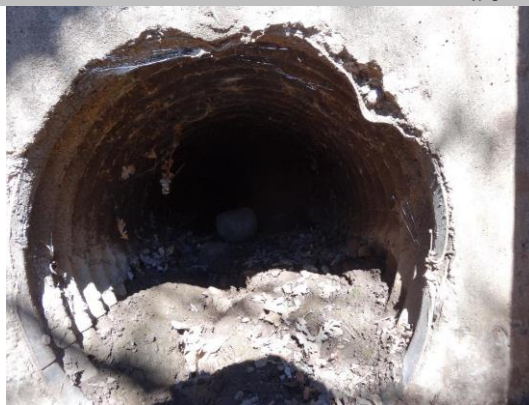
Photo 3 of 3 : UCIP\_SP\_2019\_31963\_58385.jpg

LS view: inside view of CMP on levee slope. Needs cleaning and clearing.

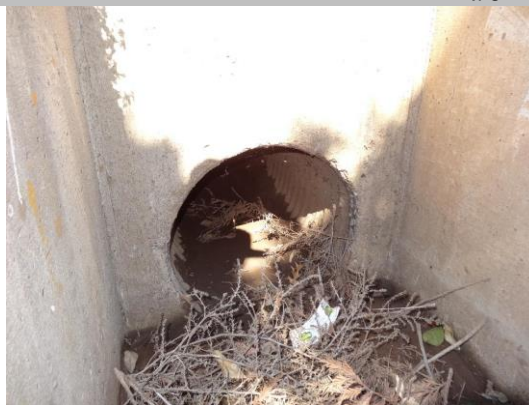
Photo 2 of 2 : UCIP\_SP\_2019\_31964\_58388.jpg

LS view: U type concrete headwall and CMP on levee slope. Vegetation debris and mud in inlet box.

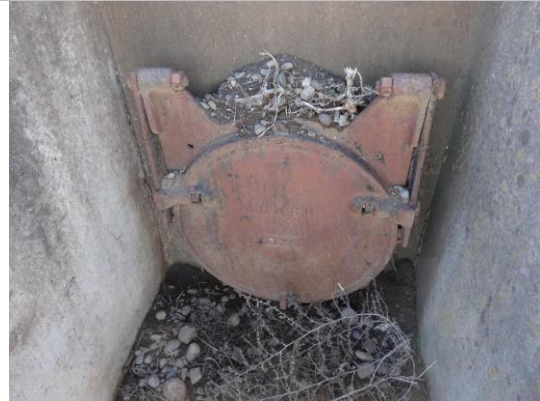
Photo 1 of 3 : UCIP\_SP\_2019\_31965\_58395.jpg

WS view: U type concrete headwall and CMP on levee slope. Vegetation debris and mud in outlet box. Needs cleaning and clearing.

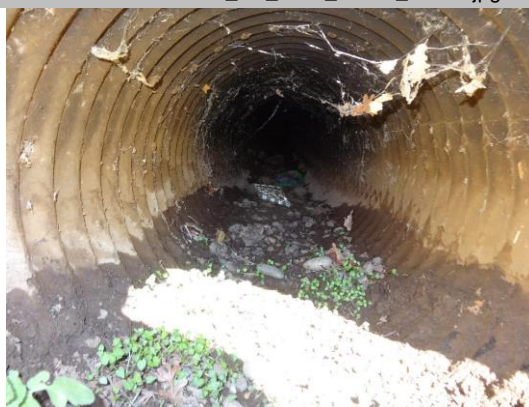
Photo 3 of 3 : UCIP\_SP\_2019\_31965\_58393.jpg

LS view: inside view of CMP on levee slope. Needs cleaning and clearing.

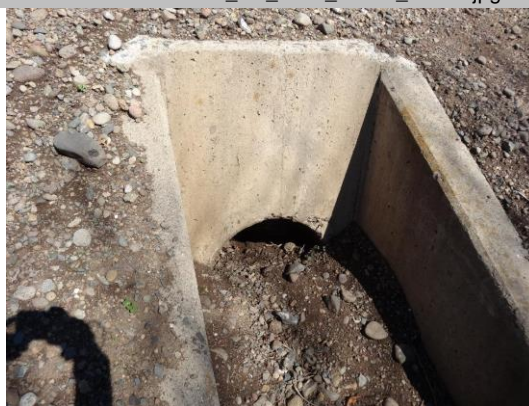
Photo 3 of 3 : UCIP\_SP\_2019\_31966\_58399.jpg

LS view: U type concrete headwall and CMP on levee slope. Vegetation debris and mud in pipe and inlet box.
